## Initial Investigation of Fire-Damaged Reinforced Concrete Structures Using Visual Inspection

**ABSTRACT:** Fire incidents can cause significant degradation to structural elements, compromising the load-bearing capacity and overall safety of buildings. After such events, rapid and accurate structural integrity assessment is essential to support technical decision-making. This study uses visual inspection as the primary method to evaluate the damage level of reinforced concrete structures in the Faculty of Engineering at Universitas Negeri Makassar following a fire incident. The investigation was conducted through direct observation of key structural elements, namely columns, slabs, and beams, and damage was classified into four categories: undamaged, light, moderate, and severe. The results indicate that the most significant damage occurred on the first floor, with 33.8% of columns and 33.4% of slabs showing severe damage. In contrast, the second and third floors remained largely intact, suggesting that the fire's highest intensity was concentrated at the ground level. Visual inspection provided an initial overview of structural conditions and identified critical areas for furth

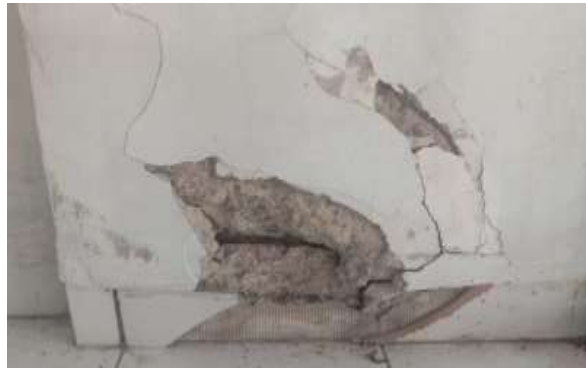
The visual inspection of structural columns revealed significant damage concentration on the first floor (Figure 1). Of the 77 columns observed, 33.8% were classified as severely damaged. These columns exhibited clear signs of concrete spalling, structural cracking, detachment of plaster layers, and exposed reinforcement, suggesting a considerable loss of load-bearing capacity. Another 5.2% of columns experienced moderate damage, while 19.5% were categorized as lightly damaged. Only 9% of the columns remained in undamaged condition. This distribution suggests that the first floor was likely the primary location of the fire's origin or experienced the highest heat intensity.

**Figure 1. Severe Spalling and Cracking on First-Floor Column**

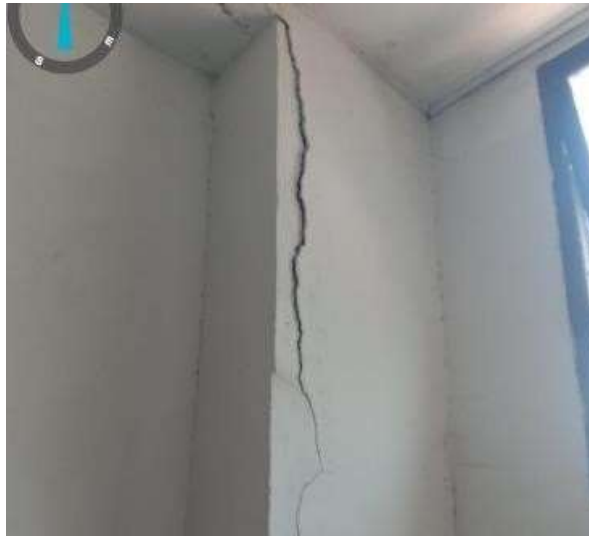
On the second floor (Figure 2), 96% of columns were in good condition, with only 4% showing signs of severe damage, such as exposed steel and brittle concrete response upon percussion. The third floor showed minimal damage (Figure 3), where 98.4% of columns were classified as undamaged and only one column exhibited severe damage characterized by bulging and significant cracking. These findings indicate that the vertical spread of the fire diminished significantly on higher floors, likely due to fire containment or the thermal gradient effect.

**Figure 2. Vertical Cracking on Second-Floor Column**

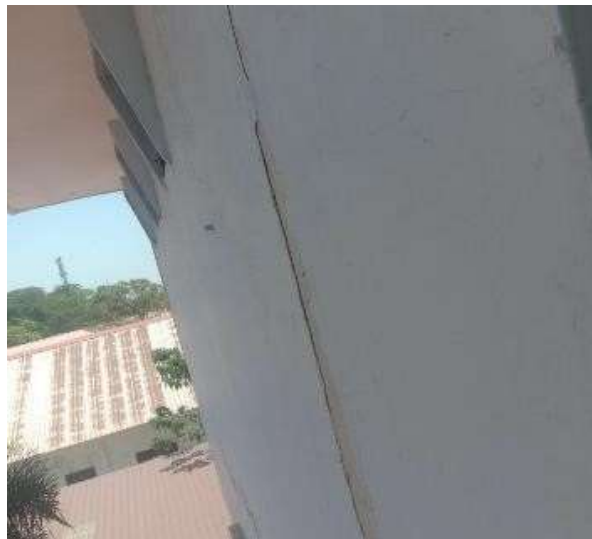
**Figure 3. Minor Hairline Crack on Third-Floor Column**

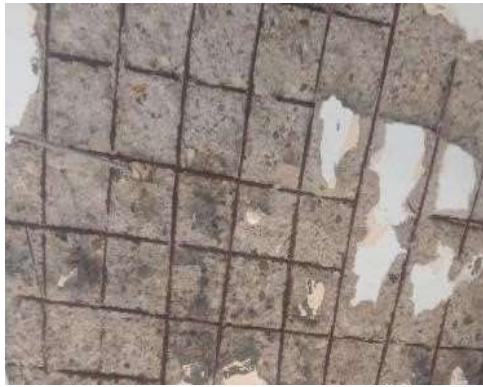
The floor slabs on the first level (Figure 4) showed substantial signs of fire-related deterioration. Of 51 observed slabs, 33.4% were severely damaged, with visible signs such as concrete crushing, reinforcement rupture, and detachment of the steel bars from the concrete matrix. Moderate damage was observed in 7.8% of the slabs, and 58.8% remained in satisfactory condition. The severity and nature of the slab damage suggest that structural performance under gravity loads would be compromised without proper rehabilitation.

**Figure 4. Severe Concrete Spalling and Reinforcement Exposure on First-Floor Slab**

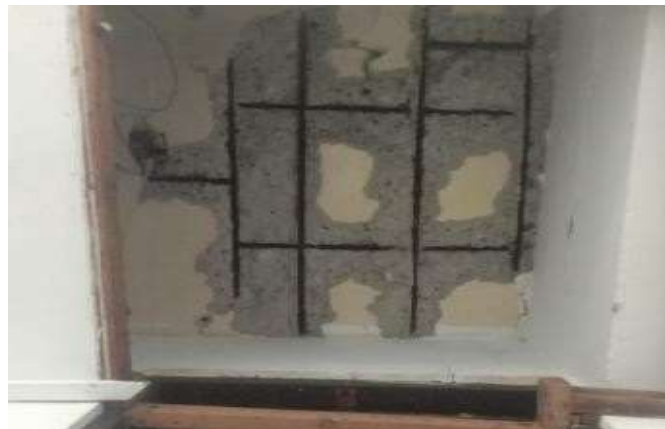
The damage was significantly less extensive on the second floor (Figure 5). Approximately 89.1% of the slabs were undamaged, 2.2% were moderately damaged, and only 8.7% exhibited severe visual defects. These results are consistent with the findings in the column assessment, reinforcing the conclusion that fire intensity was most critical at the ground level.

**Figure 5. Localized Concrete Loss and Reinforcement Exposure on Second-Floor Slab**

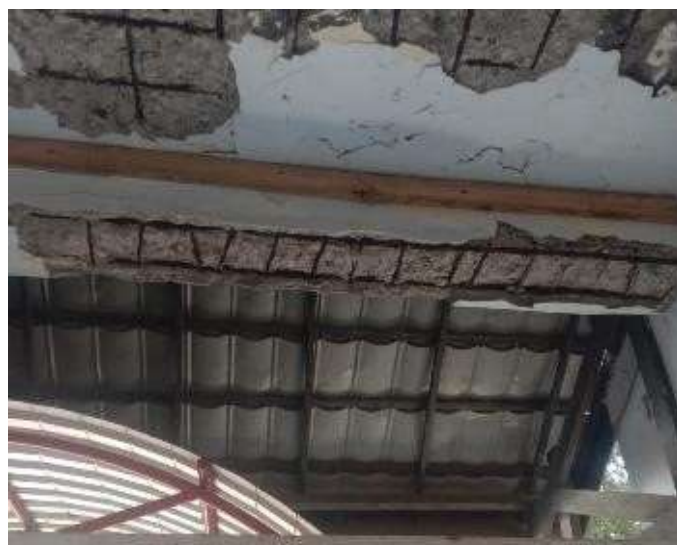
Beams were generally the least affected among all structural elements, particularly on the upper floors. On the first floor (Figure 6), out of 116 beams inspected, 7.8% showed signs of severe damage, primarily in cracking and deflection. Only 1.7% experienced moderate damage, while 90.5% were in good condition. The second floor (Figure 7) exhibited even better performance, with 95.7% of beams undamaged, 2.6% severely damaged, and 1.7% moderately affected.

**Figure 6. Extensive Spalling and Reinforcement Exposure on First-Floor Beam**

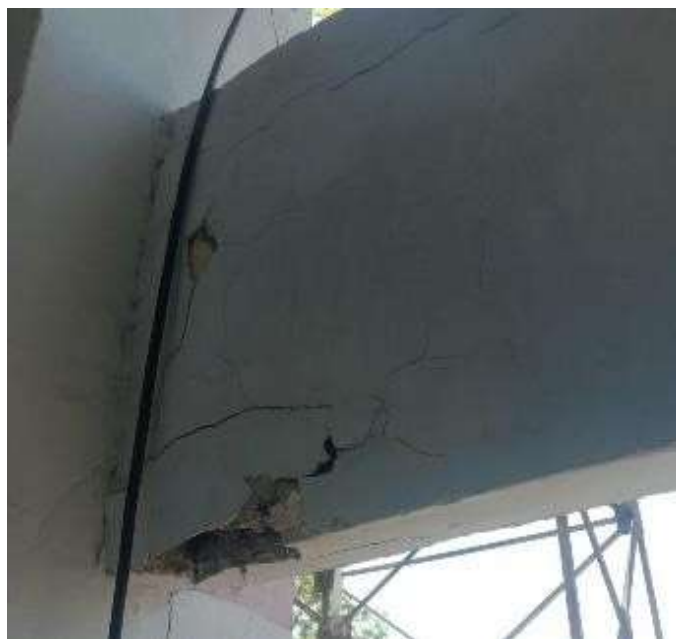
**Figure 7. Cracking and Minor Concrete Loss on Second-Floor Beam**
