IUD Displacement with Both Arms Deeply Embedded into Myometrial Tissue: Case Report

Eddy Hartono^{1,2}, Efendi Lukas¹, and Witono Gunawan¹

¹Department of Obstetrics and Gynecology, Hasanuddin University, Makassar, South Sulawesi, Indonesia

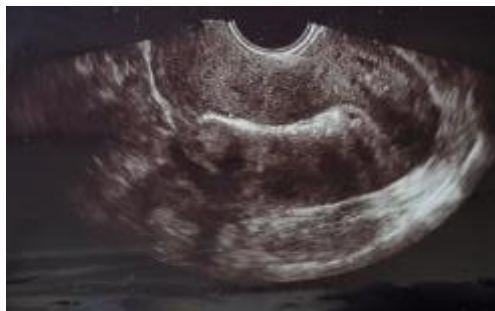
Figure 1. 2D Transvaginal sonography view of IUD confirmed that the IUD was still intrauterine

2D ultrasonography had been performed prior to trial of IUD removal (Fig. 1). The IUD stem was seen on 2D ultrasound examination but both IUD arms were barely seen on this evaluation, so we decided to perform 3D transvaginal sonography in order to have adequate spatial images of the IUD (Fig. 2). The IUD then was confirmed to be intrauterine but the stem and both arms were seemed to have displaced. Removal procedure was then initiated preceded by pelvic examination. On pelvic examination, the IUD thread was not seen, so we try to use alligator forceps blindly aiming to get the stem of IUD. This maneuver was failed at initial attempt so we decided to try it again at her next menstrual period. The second attempt that performed at her menstrual period also failed to remove the IUD so we decided to end the intervention and consider hysteroscopy as an alternative method.

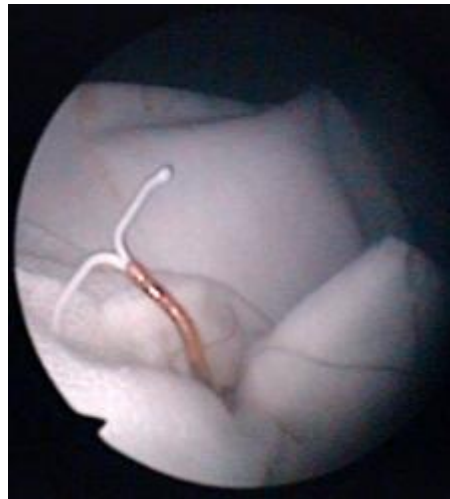
Figure 4. After-procedure picture showed bending IUD with both arms intact
